NASA TN D-2189

DESCRIPTION OF VEHICLE SYSTEM AND FLIGHT TESTS OF NINE TRAILBLAZER I REENTRY PHYSICS RESEARCH VEHICLES

*Langley Research Center
Langley Station, Hampton, Va.*

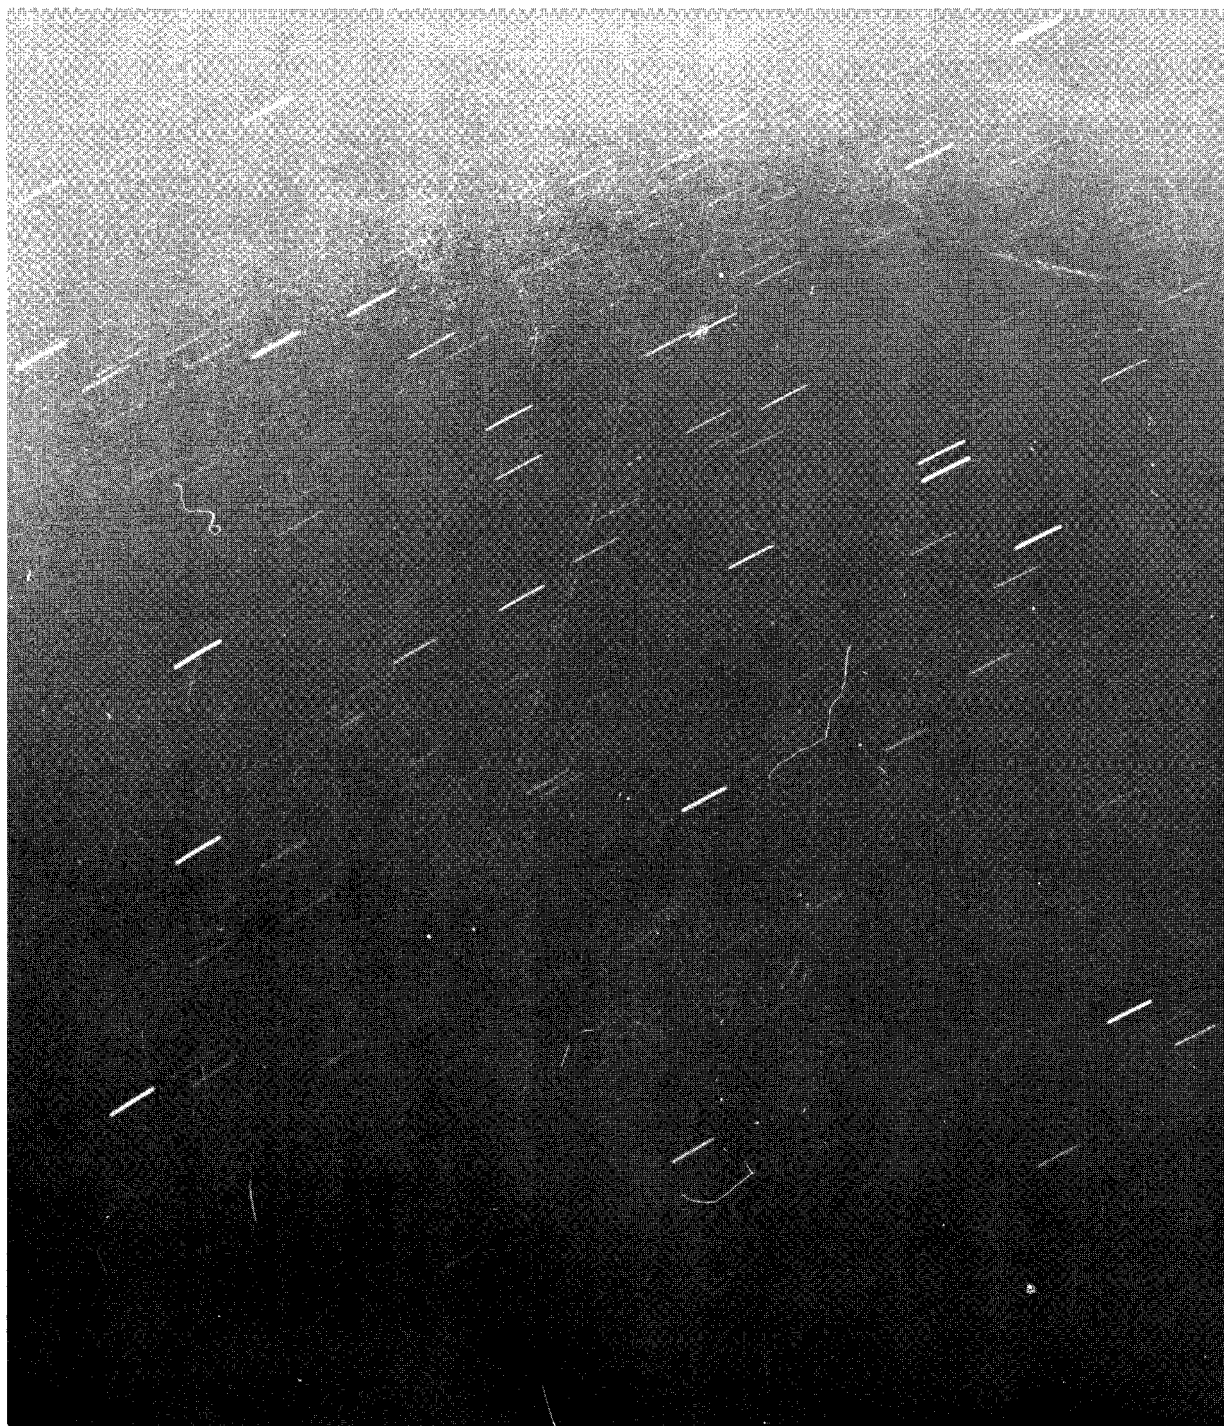
Figure 30.- Photographs of sixth-stage reentry for Trailblazer Id.

(a) Trailblazer Id; camera location: Wallops Island, Va.; trace unchopped.
